PEATWISE

Case studies, the Netherlands

Friesland, The Netherlands

WTL elevation during summer with submerged drains

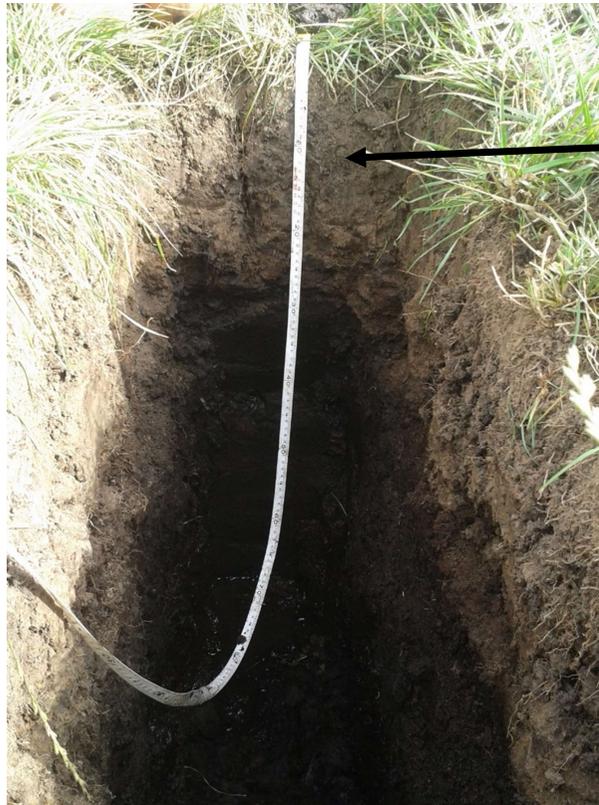
Site description Friesland

Clay layer of
around 30 cm

Layered,
unpenetrable peat

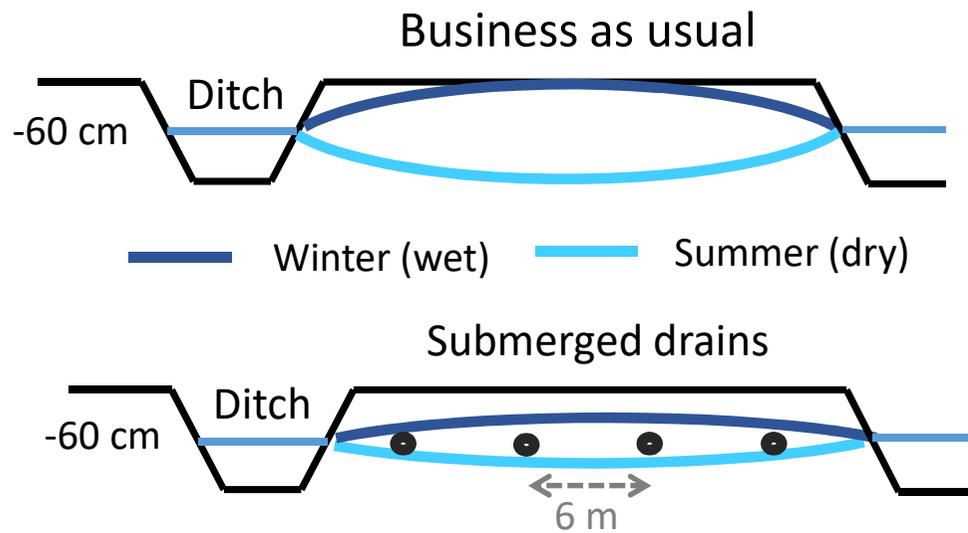
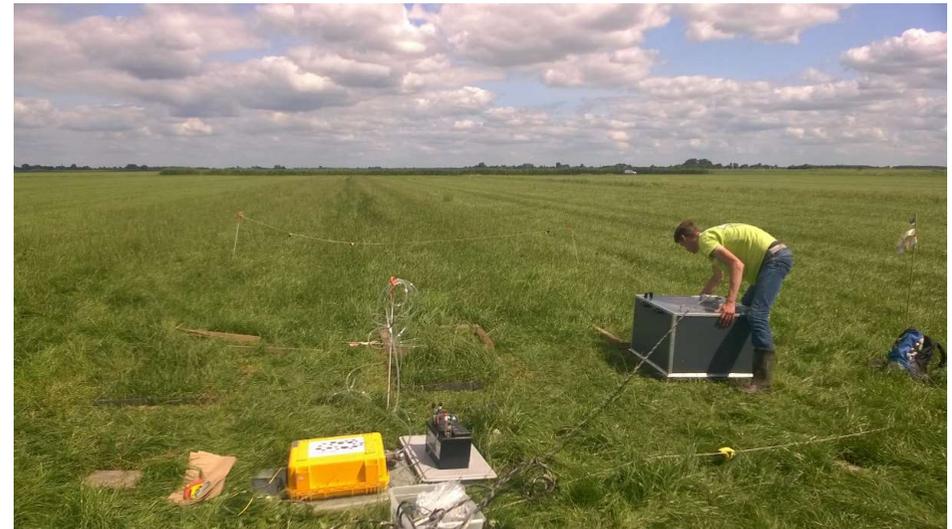
Research set-up Friesland

On 4 farms (2 included as case study site) 1 field with submerged drains and 1 control field.

Measurements on all fields: CO₂ flux, CH₄ flux, water table, soil moisture, subsidence, ...and more.

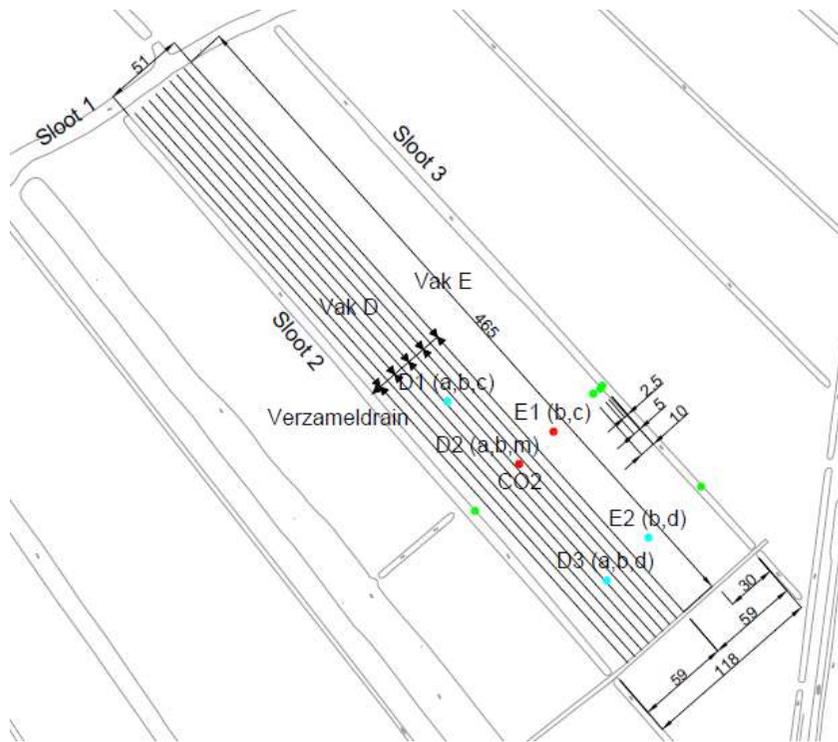
1. Gersloot

Set-up submerged drain fields
